DEPARTMENT OF TRANSPORTATION

Quality Assurance and Source Inspection

Contract #: 04-0120F4Cty: SF/ALA Rte: 80 PM: 13.2/13.9File #: 69.28**WELDING INSPECTION REPORT****Resident Engineer:**Siegenthaler, Peter**Address:** 333 Burma Road**City:** Oakland, CA 94607**Report No:** WIR-021241**Date Inspected:** 22-Feb-2011**Project Name:** SAS Superstructure**OSM Arrival Time:** 700**Prime Contractor:** American Bridge/Fluor Enterprises, a JV**OSM Departure Time:** 1900**Contractor:** Zhenhua Port Machinery Company, Ltd (ZPMC), Changxing Island **Location:** Shanghai, China**CWI Name:** Geng Wei**CWI Present:** Yes No**Inspected CWI report:** Yes No N/A**Rod Oven in Use:** Yes No N/A**Electrode to specification:** Yes No N/A**Weld Procedures Followed:** Yes No N/A**Qualified Welders:** Yes No N/A**Verified Joint Fit-up:** Yes No N/A**Approved Drawings:** Yes No N/A**Approved WPS:** Yes No N/A**Delayed / Cancelled:** Yes No N/A**Bridge No:** 34-0006**Component:** OBG Components**Summary of Items Observed:**

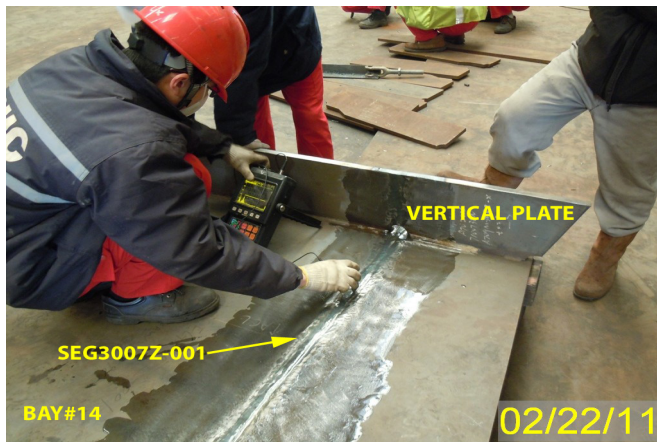
This QA inspector Witnessed UT performed by ZPMC Quality Control personnel. The member is identified as OBG Component. The component and weld designation identified as follows:

SEGMENT 13A EAST VERTICAL PLATE WELD

SEG3007Z-001 (See attached photo)
